JETSETS

Jet and Turboprop Support, Engineering, Training and Safety.

Flight control restrictions

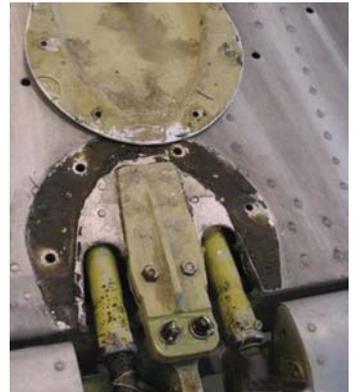
Above: example of a anti-icing residue in trim tab

Internal surfaces, such as wing and tailplane access panels, should be checked and washed out as above. Drain holes should be checked on control surfaces for signs of residues and cleared. If contamination is suspected within the flying control, access panels must be removed for further examination. All residue and gel must be removed using

hot water or hot Type I fluid. The surfaces should preferably be dried with warm, dry air after this procedure to minimise the risk of corrosion.

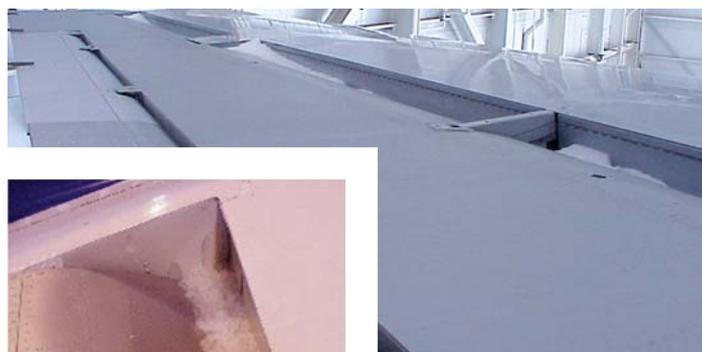
Above and inset: examples of ice pellets in the elevator hinge of a BAe 146, which if not treated, could lead to a control restriction when airborne

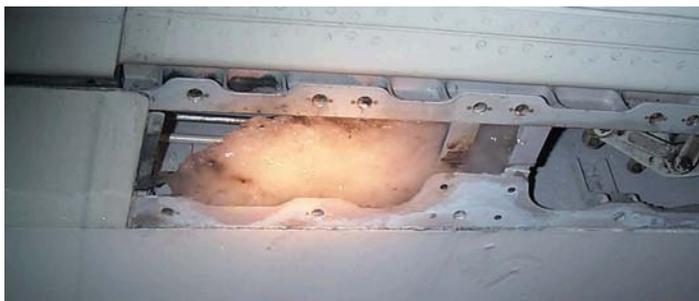
Above: example of a anti-icing residue in the leading edge of the elevator trim tab

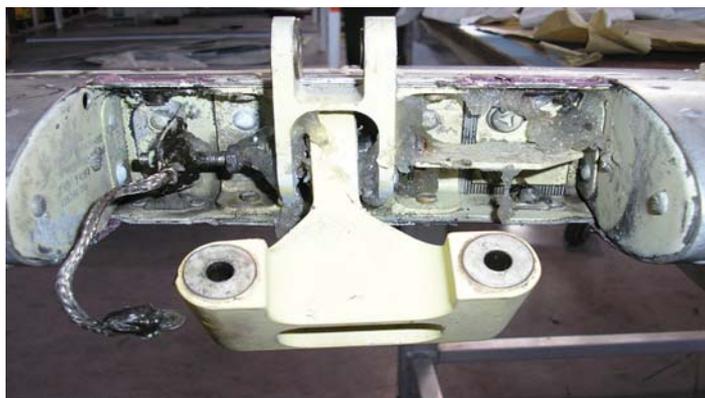
Above: an example of a anti-icing fluid residue inside primary control structure

help to prevent the build-up of residues. Low pressure dry air can also be effective in removing the residues. Residues from the exterior should be washed or

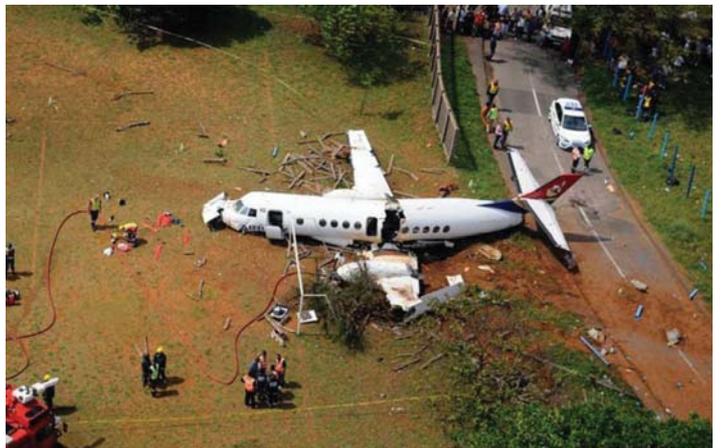
From the FDR data it is evident that the right-hand engine failed after 70 knots but prior to V1 as indicated by the right hand engine torque which started spooling down. This occurred as the Tower advised the aircraft of a smoke trail behind the aircraft. All hydraulic and oil pressures were still normal at this stage.

Above: the J41 which crashed shortly after taking off from Durban International Airport, South Africa in September 2009

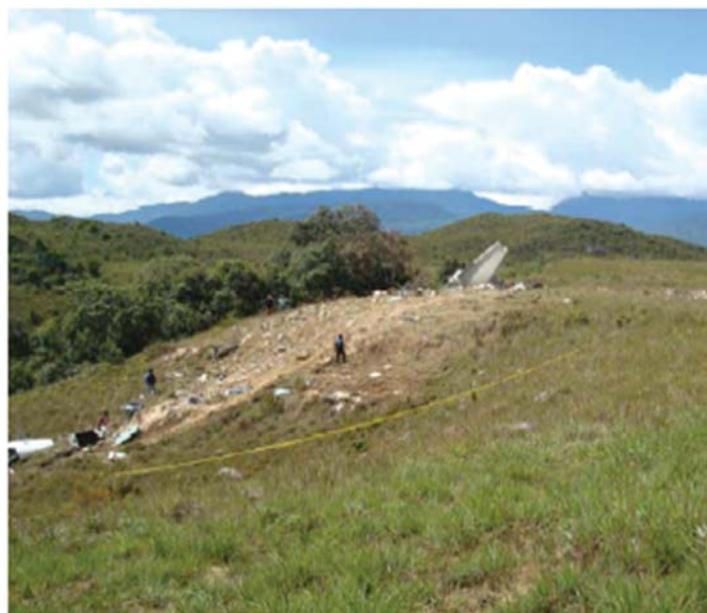
The investigation concluded that flight crew's lack of awareness of the aircraft's proximity with terrain, together with non conformance to the operator's published operating procedures, resulted in the aircraft's impact with terrain.

Below: the crash site of BAe 146 PK-BRD at Wamena, Papua
