Icing induced loss of control

JETSETS

Don't eat into your margins

How to cope with wet runways and hydroplaning

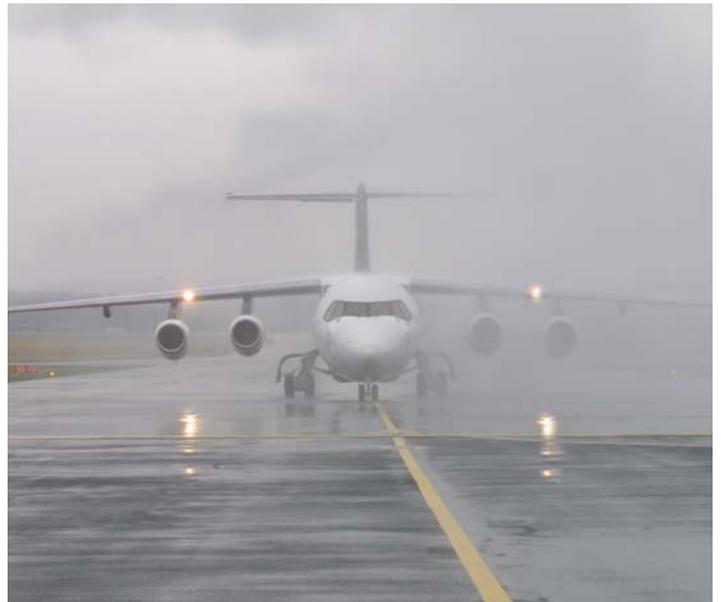
Above: wet runways can affect braking

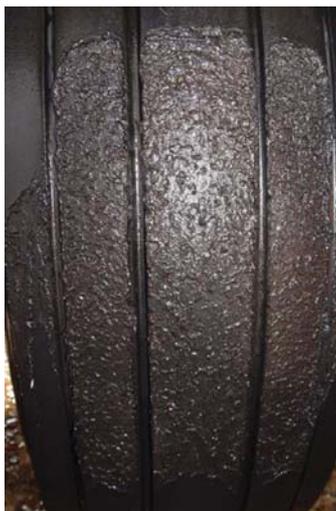
Eyewitnesses stated that the aircraft touched down about 1000 m after the threshold, and this was later refined from FDR data to 849 m. All four tyres showed traces of rubber reversion hydroplaning (Figure 1), and had left about 400 m long bright traces on the runway which were definitely caused by rubber reversion hydroplaning (runway marks left following rubber reversion hydroplaning look like they might originate from steam blasting (Figure 2)). Furthermore, melted away rubber was found on the runway (Figure 3).

The Investigation concluded that based on the slow deceleration after touchdown it was highly likely that dynamic aquaplaning occurred in the middle portion of the runway followed by rubber reversion hydroplaning which occurred when the emergency brake was activated, the anti-skid deactivated and the tyres locked. The aircraft technical log did not show any irregularities regarding the brakes or tyres, and the tyres were inflated correctly.

Above: figure 1 - marks of rubber reversion hydroplaning on the tyre

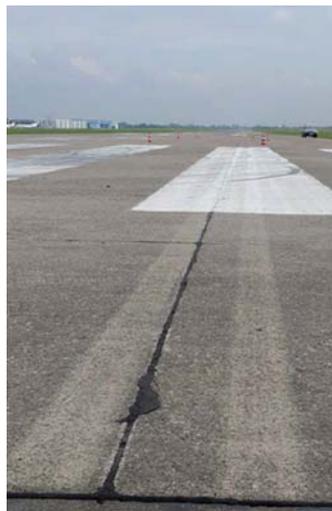
Above: figure - marks of hydroplaning on the runway

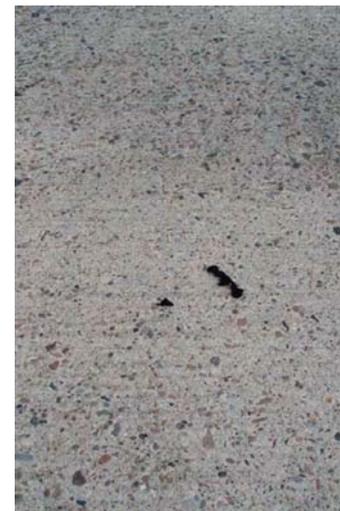
Above: figure 3 - rubber dumped from tyre

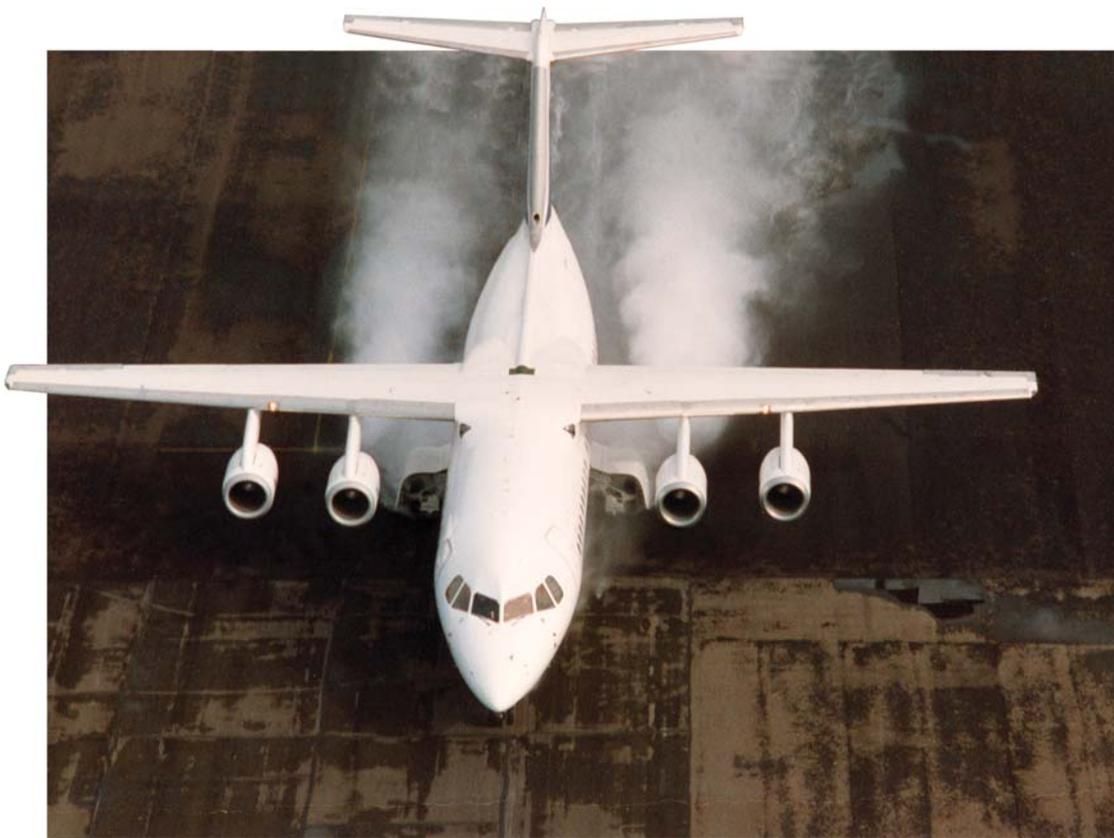
Above: wet runway contamination can cause hydroplaning

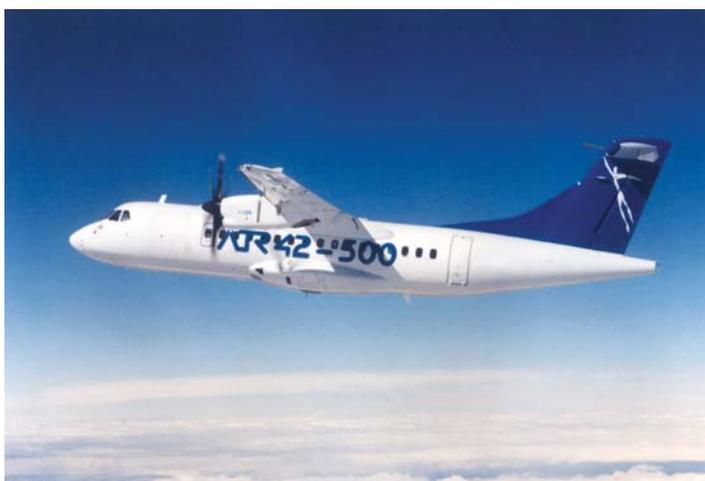
Above: an ATR 42 aircraft suffered loss of control due to an unexpected aileron hinge moment reversal due to accreted ice
