Icing induced loss of control

JETSETS

Don't eat into your margins

How to cope with wet runways and hydroplaning

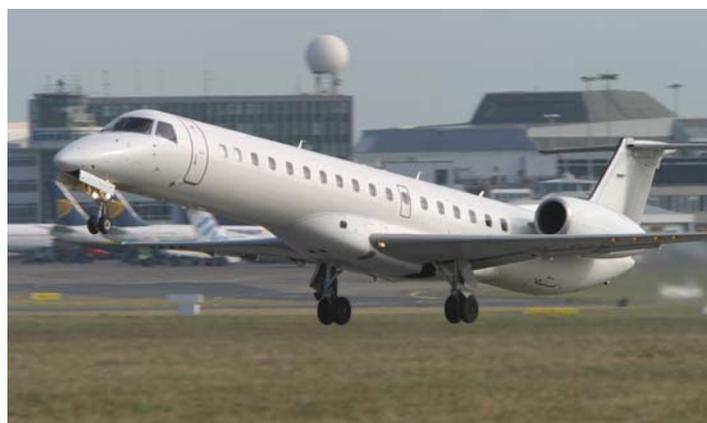
Above: an Embraer 145 similar to the aircraft that suffered an runway overshoot

- 1. **Landed slightly long.** The ideal touchdown point is 300 m from the threshold - in this instance the touchdown was at 849 m. This shortened the LDA.
- 2. **Landed slightly fast** - but only by a few knots.
- 3. **Runway condition.** The runway was wet, or even flooded, but it is not clear whether the crew were aware of this. The crew were not informed of the runway condition by ATC.
- 4. **Wind.** There was a slight tailwind.

- 5. **Incorrect braking technique.** The Aircraft Operation Manual Part B included: When hydroplaning occurs, it causes a substantial loss of tyre friction and wheel spin-up may not occur.
 - The approach must be flown with the target of minimising the landing distance.
 - The approach must be stabilized, and landing on centre line in the touchdown zone.
 - The touchdown should be firm to penetrate the contaminating

- A good landing starts with a good approach.
- Think before accepting a downwind component.
- Land in the right place at the right speed.
- If in doubt go around.
- Trust the systems and brake for effect, not comfort.

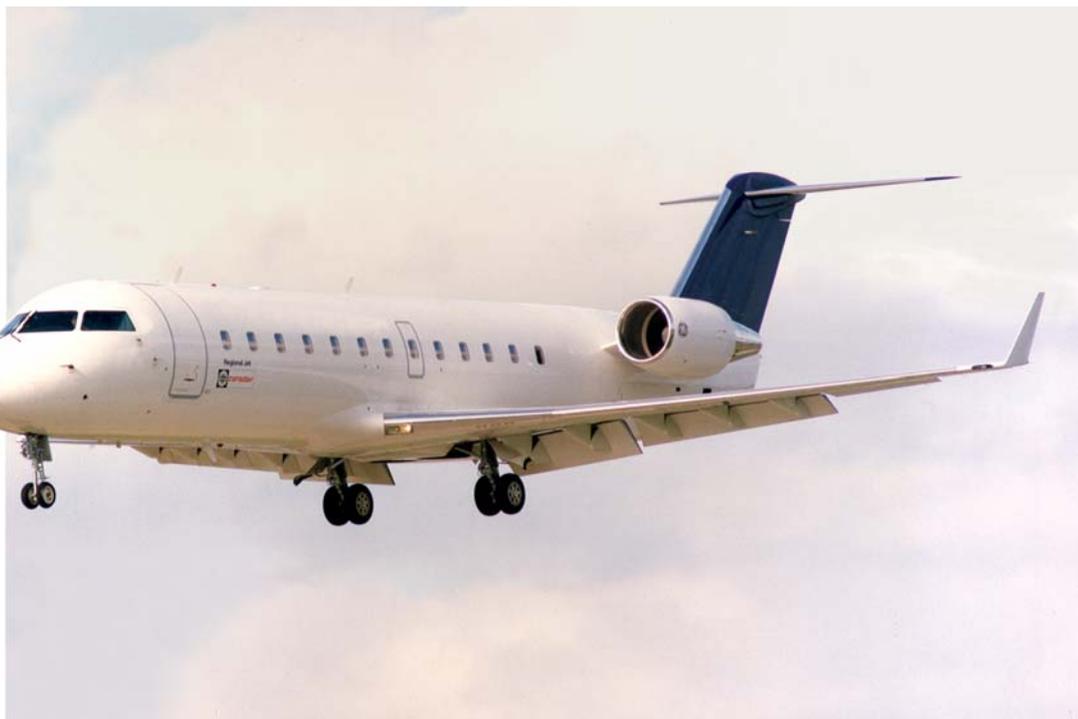
While holding in VMC we were cleared to descend to FL 150 and were IMC. Shortly after entering the clouds aircraft icing began to develop rapidly, being clearly visible at the wiper blade posts and cockpit window frames. Engine vibration was felt immediately. As we expected a 40 minute hold we asked to climb to VMC, but initially we were only cleared to FL160. Shortly after, the engine vibration increased rapidly, and after a few moments

Above: Canadair Regional Jet (CRJ)

cm fore and aft). There was no mechanical damage or fan imbalance on the engines, and the incident was put down to fan blade icing.

- First symptoms of icing can be detected by observing ice build-up on small objects like wiper blade posts.
- Sudden icing of the window frames is a sign of severe icing.
- Engine fan blade icing is often announced with engine vibrations.
- Due to ice shedding, the vibrations may be accompanied by sharp metallic noise as ice impacts the inside of the nacelle.
- Check the procedure for a an ENG VIBN caption
- In icing conditions, increase fan RPM in order to shed the ice. A higher fan speed reduces the risk of blade icing.
- Fan blade icing directly reduces the aerodynamic effectivity of the fan rotor, leading to significant performance degradation although the gas generator is at full thrust.
- Clean fan blades are less likely to pick up ice.

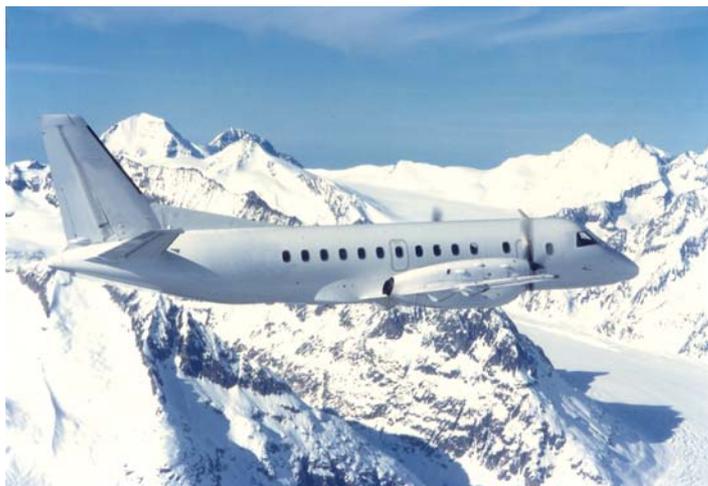
Above: a Saab 340 similar to the aircraft involved in an icing incident in Australia

The Australian Transport Safety Bureau (www.atsb.gov.au) report that the SAAB 340 crew commenced descent to MDA with a low power setting, and reported that the visibility alternated between visual and instrument flight conditions. During the descent the engine anti-ice was on but not the propeller de-ice, nor had the airframe boot de-ice

autopilot to turn right to begin tracking downwind. At about this time PNF noticed that the airspeed was decreasing and called 'speed'. As PF applied power to compensate for the decreasing airspeed, the aircraft rolled to the left and pitched down without warning. During the recovery from the steep pitch and bank angles, the aircraft rolled to the right and descended to 112 feet AGL. PF regained control of the aircraft and carried out an uneventful landing. The aircraft's aerodynamic stall warning system did not activate

during the initial roll to the left, but the autopilot disconnected during the subsequent roll to the right due to activation of the stall warning. The investigation determined that, following altitude capture by the autopilot, the airspeed continued to decrease, and the aircraft stalled. The stall occurred prior to the stall warning operating. The investigation found that it was possible for the aircraft to stall prior to activation of the stall warning system if ice had accumulated on the wings.

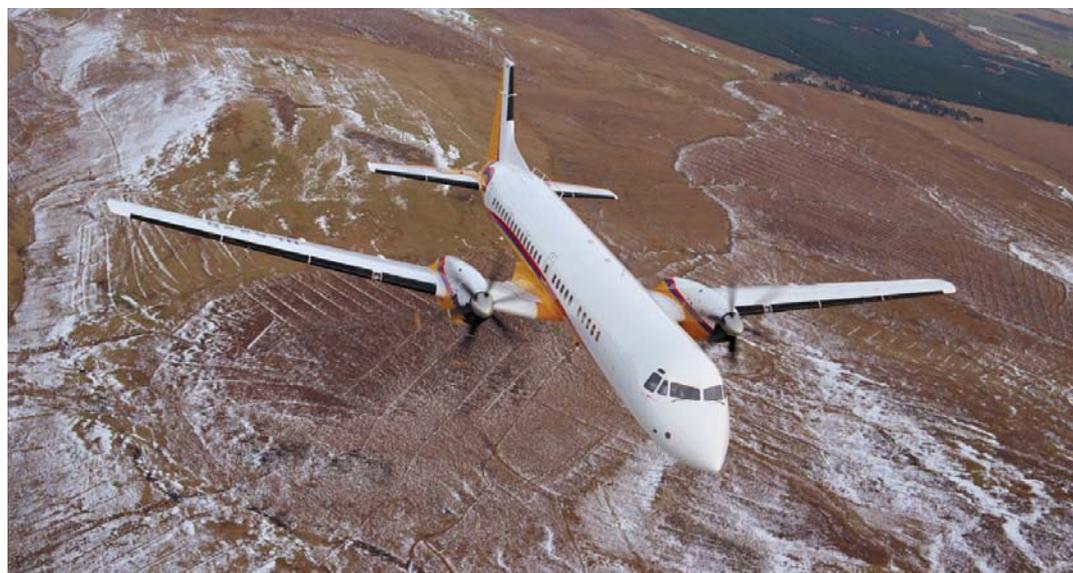
The 1992 UK Air Accident Investigation Board report stated that an ATP crew were en-route to the Channel Islands, and the aircraft entered cloud about 3000 feet below cruise height. The crew observed sleet and rain in the cloud although the only indication of airframe ice was a thin layer of what the crew described as rime ice on the

in the heading mode with the attitude being controlled by the autopilot pitch wheel. The aircraft began to experience vibration which rapidly increased in severity. Both pilots had experienced propeller icing and the associated vibration, but on this occasion they thought it to be more severe. Shortly after the onset of the vibration the left wing dropped and the aircraft began to descend. The aircraft initially pitched down approximately 15 degrees and began a rolling oscillation. The commander disengaged the autopilot and felt that the aircraft was slow to respond to aileron control inputs and large bank angles were reached, particularly to the left where a single peak 68 degrees of bank was recorded. The aircraft descended below the cloud and at about that time the vibration subsided. As the commander stabilized the roll, the

Above: an ATP was involved in an incident whilst en-route to the Channel Islands

Following the ATP incident it was found that the Cl max reduced from 1.6 to 0.9, and the stall speed increased from about 110 knots to 140 knots.

- At the first sign of stall (activation of stall warning device, uncommanded roll, buffet or other aerodynamic cues).
- Apply nose down pitch control.
- Apply full power.
- Initially try and stop further roll.
- When roll control regained roll wings level and recover to a climb.
