EASA PART 21 J & G repair solutions

Case study 4 – Avro RJ ground taxiing incident repair

Following a ground taxiing incident an Avro RJ85 sustained damage to both the front and rear of the fuselage.

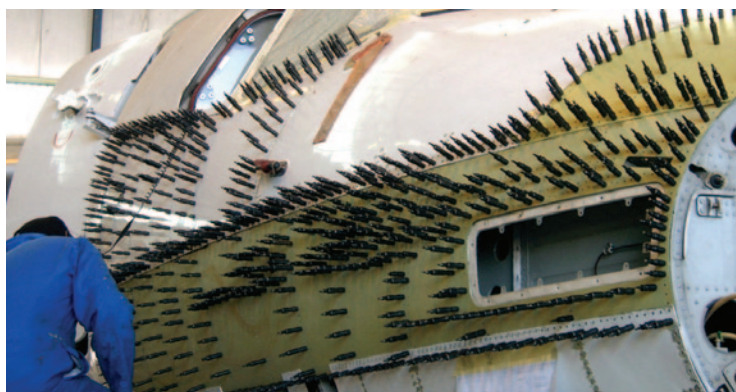
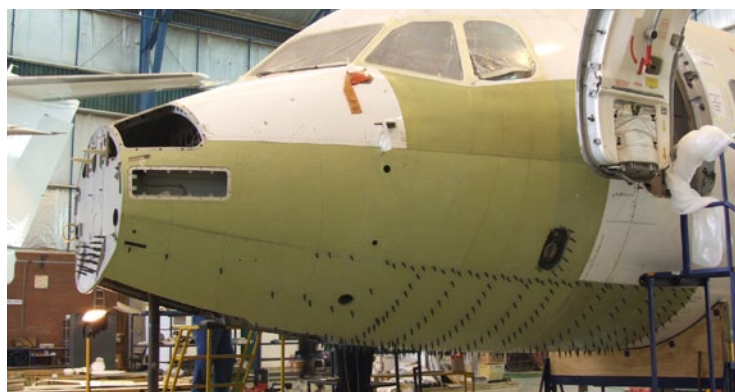
The Aircraft sustained significant damage to the forward fuselage which extended from frame 1 through to frame 15 with a total of six forward skins and for the first time a complete frame 9 having to be changed.

Rear fuselage frames 37, 37X, 37Y and 38 were damaged and the rear keel skin and strike indicator was replaced.

From the damage report a complete repair scheme was designed for both the front and rear fuselage.

The Operator handed the aircraft over to the repair team, the work was completed and the aircraft towed out of the hangar for the paint shop on schedule, after 70 days and a total of 7,800 man/hrs.
